# Service Bulletin

**Bulletin No:** 2009-1-01

**Subject:** Protective Foil

**Affected Models:** 2009 Bearcat Z1 XT, F5, F6, F8, T500, and TZ1 models

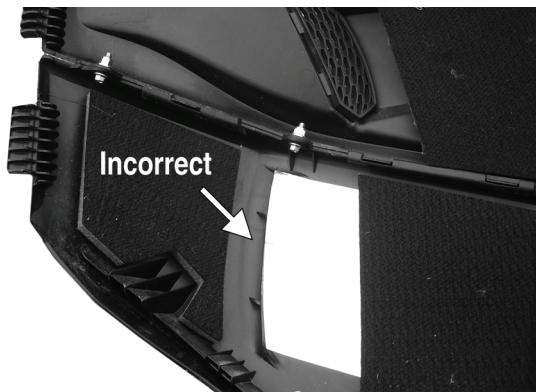
Fig. 1

**Condition:** It has come to our attention that the protective foil on the affected models was improperly positioned on the right-side panel. See Fig. 1. Failure to properly position the protective foil may result in damage to the right-side panel.

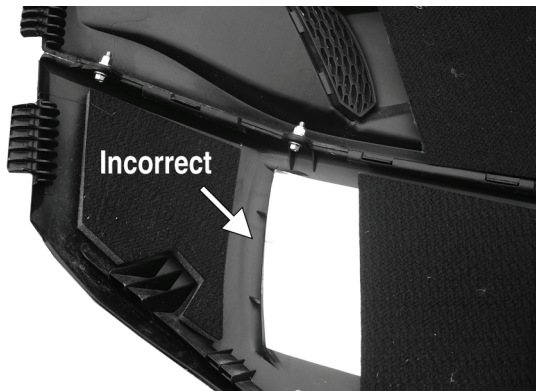
III. 1

Nous avons remarqué que la feuille métallique protectrice n'a pas été placée correctement sur le panneau latéral droit de certains modèles visés. Consultez l'illustration 1. L'installation incorrecte de la feuille métallique protectrice peut entraîner l'endommagement du panneau latéral droit.
