Service Bulletin

Bulletin No: 2010-1-08

Subject: Upper Rear A-Arm Axle

Affected Models: All 2010 500 Sno Pro (2010 600 Sno Pro*)

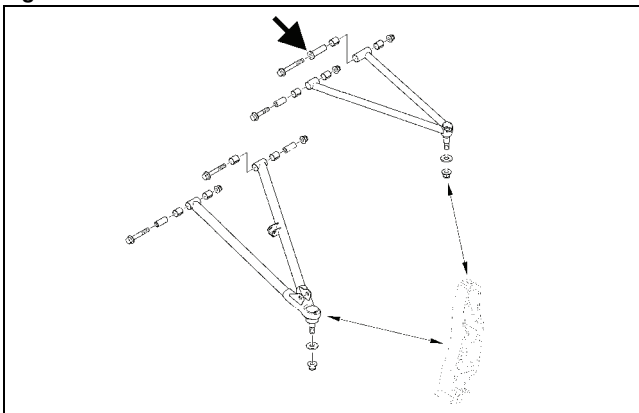
Condition: On the affected models, the upper rear A-arm axle was installed in the upper A-arm from the rear which is **incorrect**.

2. Remove the upper rear axle from the upper A-arm and install from the front. See Fig. 1 and 2.

Solution: Remove the upper rear A-arm axle from the upper A-arm; then install A-arm axle from the front according to the instructions below.

Instructions: 1. With the front of the snowmobile elevated, remove the left-side lock nuts and cap screws securing the upper A-arm to the chassis.

3. Secure the upper A-arm to the chassis using existing cap screws and lock nuts; then repeat for opposite side. Tighten to 40 ft-lb.

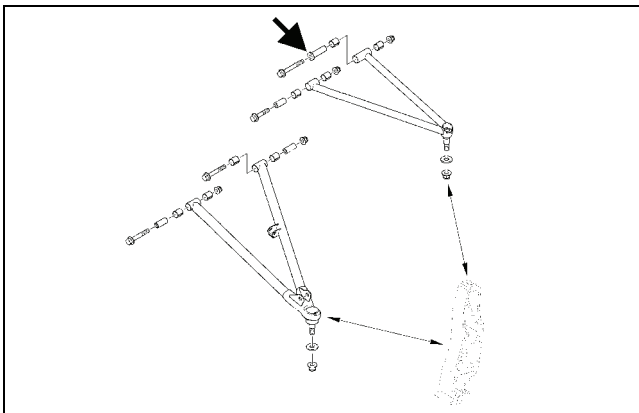
III. 1

Condition: Sur les modèles concernés, l'axe de bras en « A » arrière supérieur a été installé sur le bras en « A » supérieur en partant de l'arrière, ce qui est incorrect.

1. En ayant d'abord élevé le devant de la motoneige, retirez les écrous de blocage et les vis à capuchon du côté gauche fixant le bras en « A » au châssis.
2. Retirez l'axe arrière supérieur du bras en « A » supérieur et installez-le en partant de l'avant. Consultez l'III. 1 et 2.

Solution: Retirer l'axe de bras en « A » arrière supérieur du bras en « A » supérieur; installer ensuite l'axe de bras en « A » en partant de l'avant conformément aux instructions ci-dessous.

3. Fixez le bras en « A » supérieur au châssis à l'aide des vis à capuchon et des écrous de blocage retirés au début; répétez du côté opposé. Serrez à un couple de 40 lb-pi.
